# Marlborough's East Coast - Technical Report

**MARLBOROUGH  
DISTRICT COUNCIL**

**Prepared by  
Marlborough District Council  
22 March 2019**

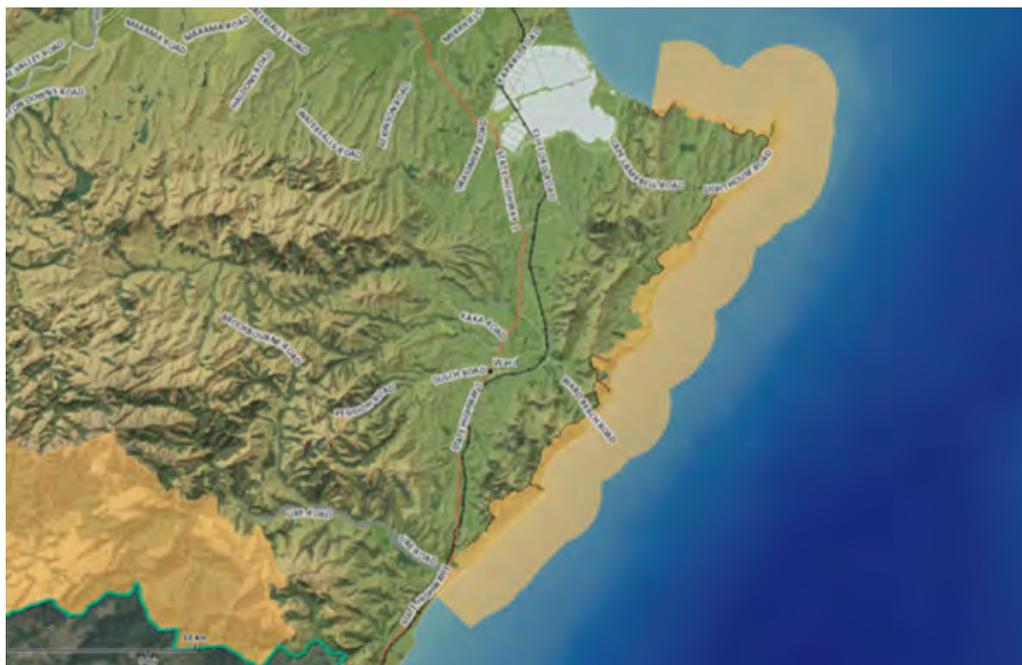
**Map 2: The ONL following the coast from Marfell's Beach to the Waima. Source: Marlborough Environment Plan, Volume 4, Map 9**

As a result of Boffa Miskell's assessment the ONL has been refined and extended to include the coast in the Marlborough Environment Plan notified on 9 June 2016.

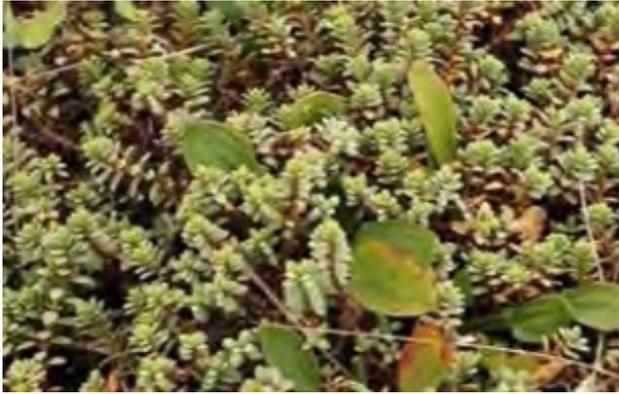
Figure 10 Pinotora (*Pimilea prostrata*) must expand down to the new storm beach area for invertebrates that live there to survive.

- At the old interface between storm beach and pasture, lizards live among washed up logs which will eventually rot *down* and disappear. Lizards will need to relocate to new habitat as it establishes further down the beach.
- *Pimelea prostrata*, *Raoulia* mat daisies and a sprinkling of grasses growing amongst sand provide habitat for the *Pimelea* looper moth and *Pimelea* leaf roller. For these and other creatures to survive, this zone needs to move down into the new storm beach area once it has collected enough driftwood to support them.

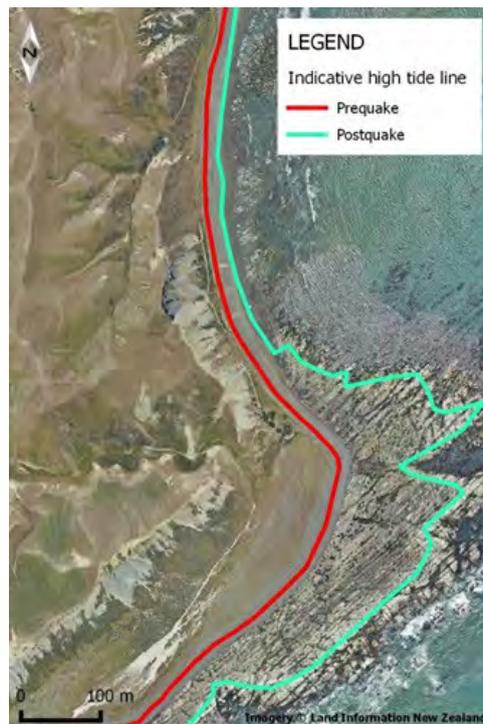
Figure 13 Long Point pre and post-quake high tide line (right) Source: University of Canterbury

The coastal deformation that occurred in the Kaikōura earthquake is the most highly variable observed in any global earthquake in modern times. Along 110 km of coastline, the vertical displacement ranged from -2.5 to 6.5 m. GNS measured the coastal deformation using a combination of field surveying, satellite measurements and differencing between pre- and post-earthquake high-resolution topographic surveys. They defined the coastal stretch impacted by the earthquake as the region from Haumuri Bluff to Cape Campbell (a straight line distance of 110 km) then 80 km (73 %) of the coastline underwent uplift, with 48 km (44 %) undergoing uplift of > 1 m. Around 28 km (25%) underwent a minor amount of subsidence (<0.5 m), with only a very localised area (2 km around the Kekerengu fault) undergoing > 1 m subsidence. Only a very minor stretch (3 km, 2%) of coastline around Peketa was not impacted by coastal deformation. The entire Kaikōura Peninsula and much of the coastline north and south of the Peninsula was uplifted by between 0.8 and 1 m. Uplift of the Peninsula and the surrounding area is attributed to an entirely offshore fault called the Kaikōura Peninsula fault. Two strands of the Papatea fault cross the coastline at Waipapa Bay and between these faults the land was uplifted 5 - 6 m, creating a new rocky coastal platform extending 200 - 300 m offshore from the pre-earthquake coastline.

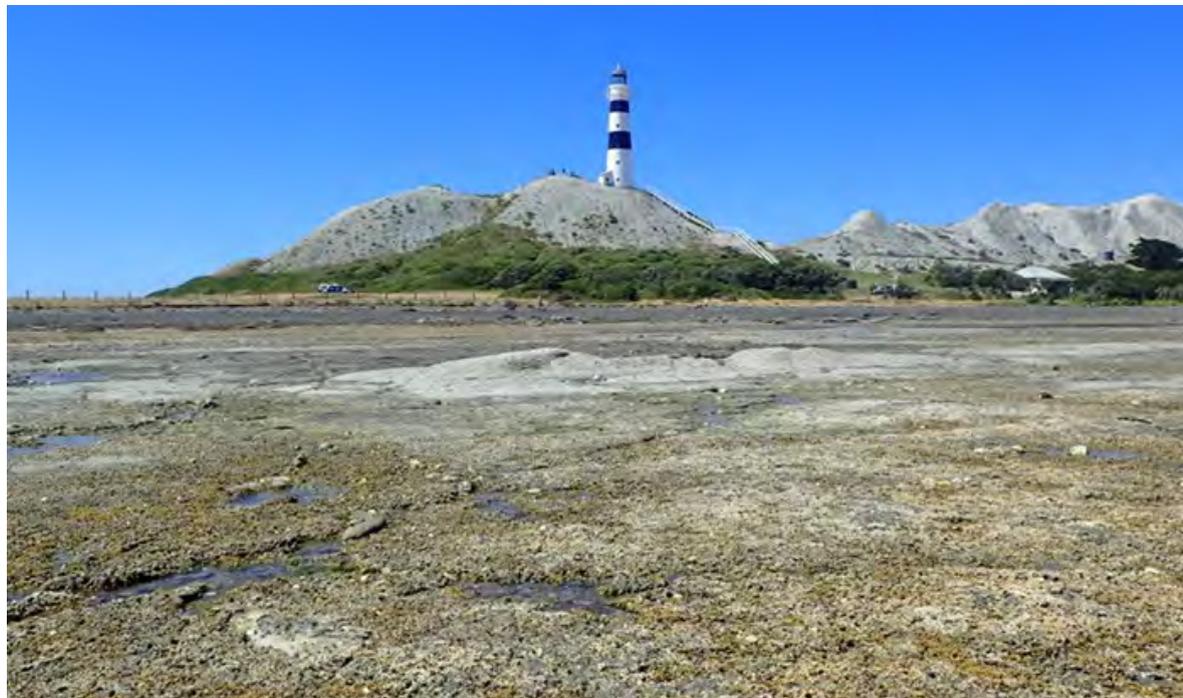
**Figure 14 Exposed limestone/mudstone platforms at Cape Campbell post-quake, with close to total loss of seaweeds**

The existing reef ecosystems were badly damaged by the quake. Large areas are now above water for most or all of the time and support no marine life. The marine ecosystems present in the focus area are shown on the maps in Appendix 8.

- Uplift thrust some reefs and algal beds out of the water.
- Structural change of some areas still covered by tide.
- Insufficient new reef emerged to replace what was lost.

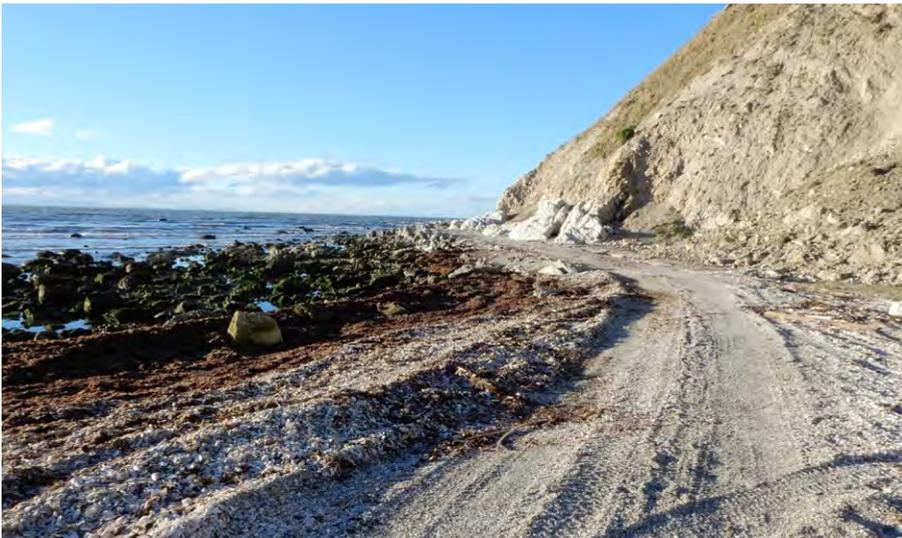
**Figure 18 Well-worn vehicle route around Mussel Point**

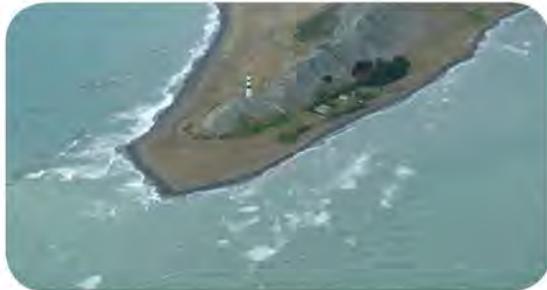
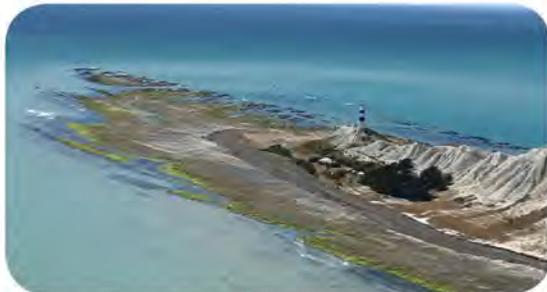
Cape Campbell before the earthquakes

Cape Campbell after the earthquakes.

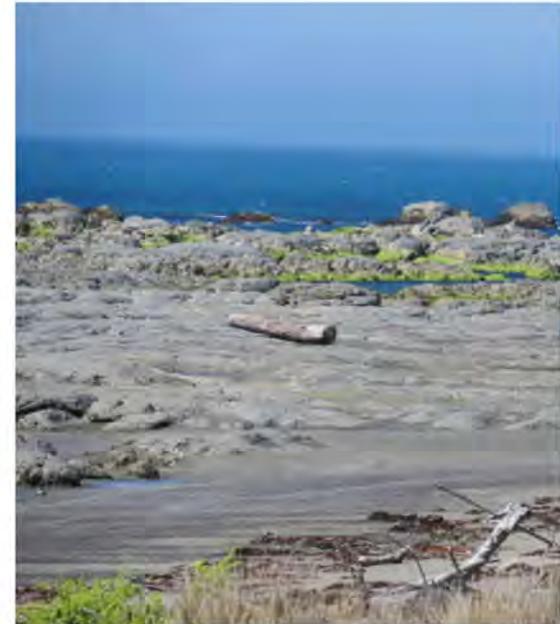
Uplifted beach platform - Cape Campbell
